A notebook for the diagnosis and maintenance of gravity-flow water systems

This practical guideline aims at helping persons in charge of organising and conducting (or facilitating) diagnoses of gravity systems. It presents a definition of what is meant by diagnosis, and situates the diagnosis in the different steps of a preventive maintenance process. After giving a general overview of the different components of a gravity system, a description of what must be looked at for each component is described. A summary table, in the form of a check-list is presented on the last page

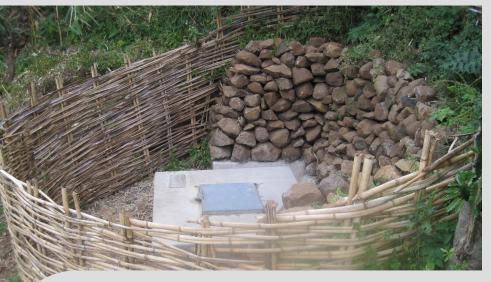
Protection of the spring environment

- Earth retaining structures are located above the spring box and protect the box from overtopping of soil and prevent land slide that can harm the structure. These structures can be composed of dry or masonry wall, gabions or vegetalised wall. The protection canal diverts the flow of upstream surface water away from the structure and the surrounding.
- Antierosive measures including diversion canal in the upper part contribute to decrease the speed of the surface water and to limit soil erosion.
- The fence and protection perimeter prevent unwanted or unauthorized entrance of people and animal. It also secures and protects the perimeter of the spring against any pollutant. The vegetalisation of the spring watershed facilitates water infiltration in the water table and contributes to preserve the spring and to prevent yield reduction.

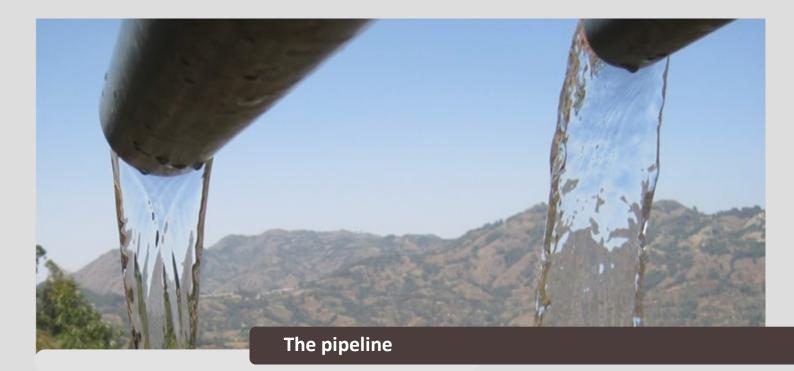
The diagnosis of the pipeline ensures that the water is carried from one point (the spring or a distribution box) up to another (usually, a water point) without affecting both its quantity and its quality. For that, it is necessary to inspect the pipeline and its surroundings all along the line, with a particular attention given to exposed areas like stream or gulley crossing. One should make sure that the pipes are well buried and protected (pipes cannot be exposed). Leakages can be detected by observing possible trace of moistures on the floor around the pipeline and by comparing yield at the intake and outlet of a set of pipes.

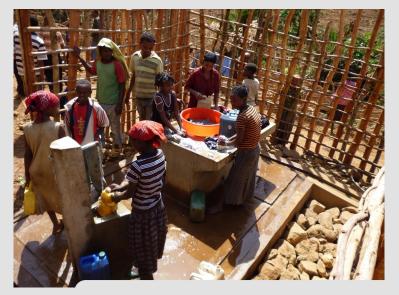
The water point

The fountain

- <u>A slab</u> on which the fountain stands . The slab allows the users to walk on a clean, firm and not slippery floor in order to fetch water easily . A major role of the slab is to drain out the water from splashes or heavy rains to ease the access. The slab must be easy to wash regularly.
- <u>An outlet pipe giving</u> a continuous flow of sufficient water that can easily be fetched (non-splashing and controlled flow). When there is a reservoir, a tap (local or talbo) is installed.
- <u>A standing concrete column</u> that must be well anchored to protect the pipe from any damage.
